# URGENT MEDICAL DEVICE CORRECTION

August 4, 2025

Baxter Healthcare Corporation is issuing an Urgent Medical Device Correction for the **Novum IQ** Large Volume Pump (LVP) and **Novum IQ** Syringe Pump (SP) due to software anomalies that may result in a blank Run screen (LVP and SP) and/or false motor movement system error (SP only).

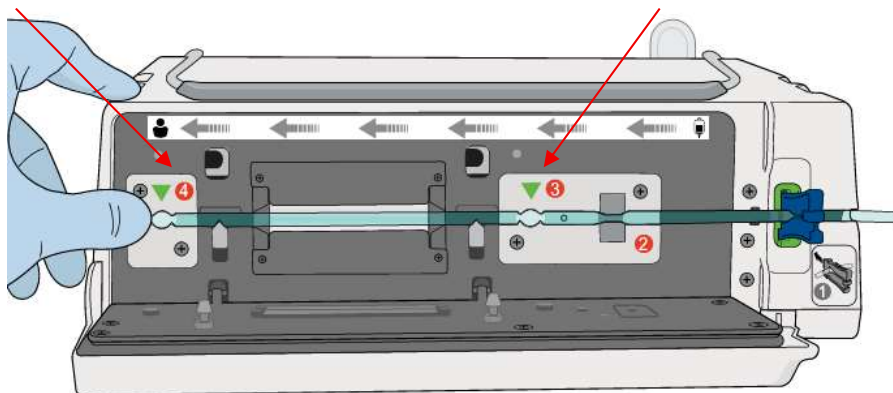
*Figure 1. Red arrows point to load points 3 and 4 on the **Novum IQ LVP**.*

2. If an alternate pump is not available or appropriate for patient care involving high risk medications and/or critical illness, you may continue to use the **Novum IQ LVP** and **Novum IQ Syringe Pump** consistent with the following actions:
  - If a blank Run screen is displayed during an infusion on the **Novum IQ LVP**, the user should open the door, press the tubing into load point 3, then load point 4, to turn the light green (pictured in Figure 1 below), and close the door. If a blank Run screen is displayed during an infusion on the **Novum IQ Syringe Pump**, the user should unload, then reload the syringe. If these actions do not resolve the blank screen, both LVP and Syringe Pump users should power-cycle the pump, select “Yes” to the new patient prompt, and reprogram the infusion.
