Customer Service Bulletin

Subject: CSB-CVSM, SECURE SURETEMP USB CABLE

Product(s) Referenced: CVSM – Connex Vital Signs Monitor

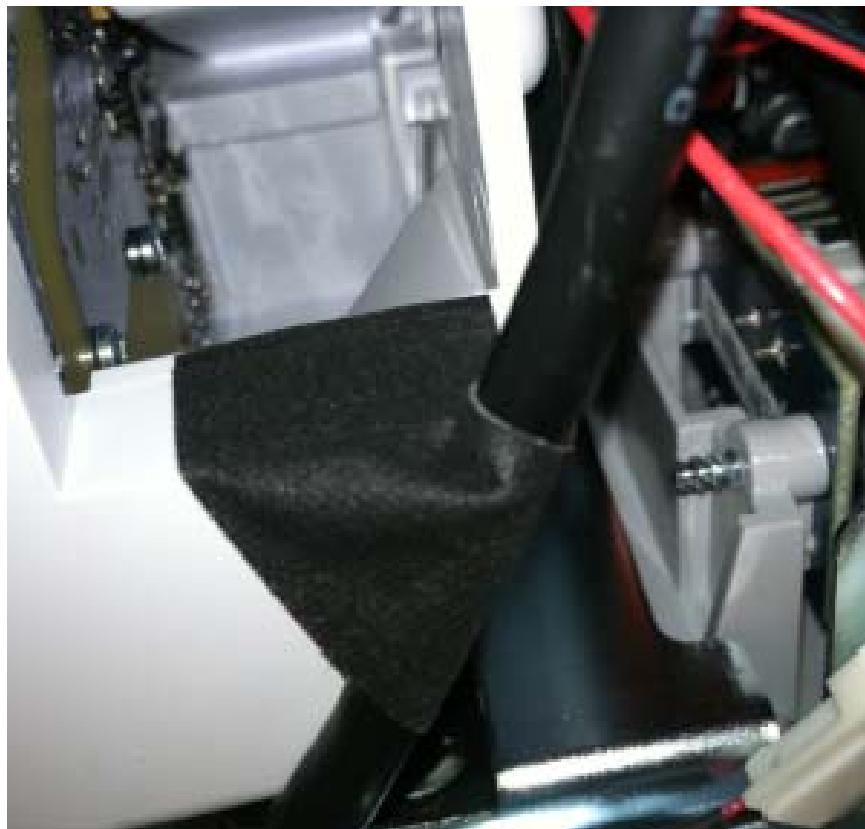
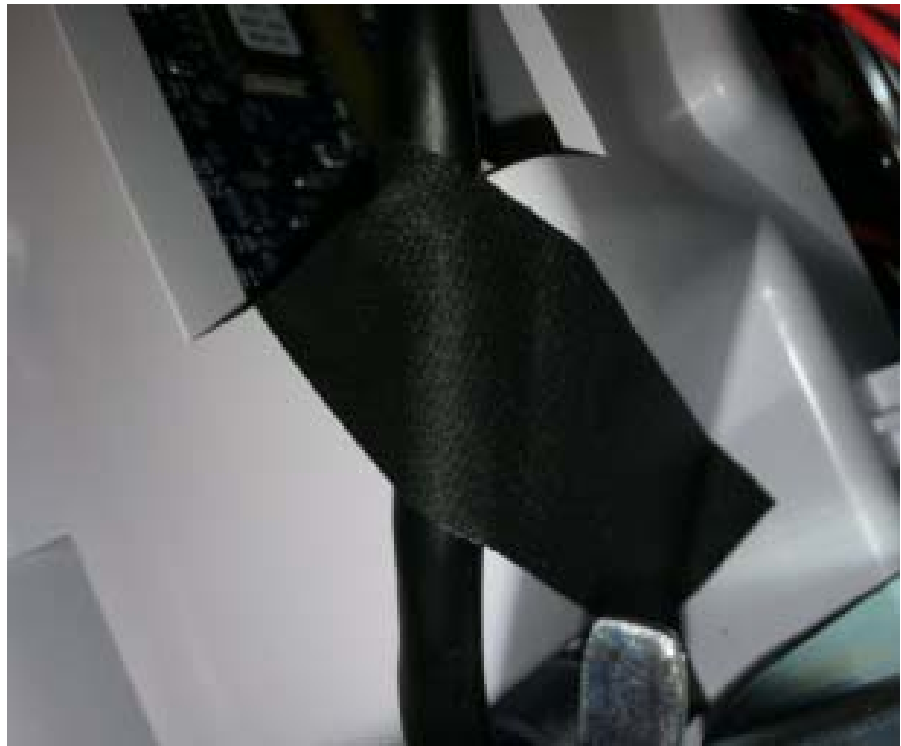
2. Clean the surface on the Suretemp module where the tape will be applied with isopropyl alcohol.
3. Secure the USB cable connecting the temp module to the MCE board as shown in the photos below using a single 2 inch length of tape (103576).
